NEAL DAM  
WASHINGTON COUNTY, COMMONWEALTH OF PENNSYLVANIA  
NDI No. PA 00494  
PennDER No. 63-68

⑥ PHASE I INSPECTION REPORT  
NATIONAL DAM INSPECTION PROGRAM.

Neal Dam, Washington County, Pennsylvania  
NDI No. PA 00494, PennDER No. 63-68  
Tributary of Chartiers Creek  
Inspected 6 December 1979

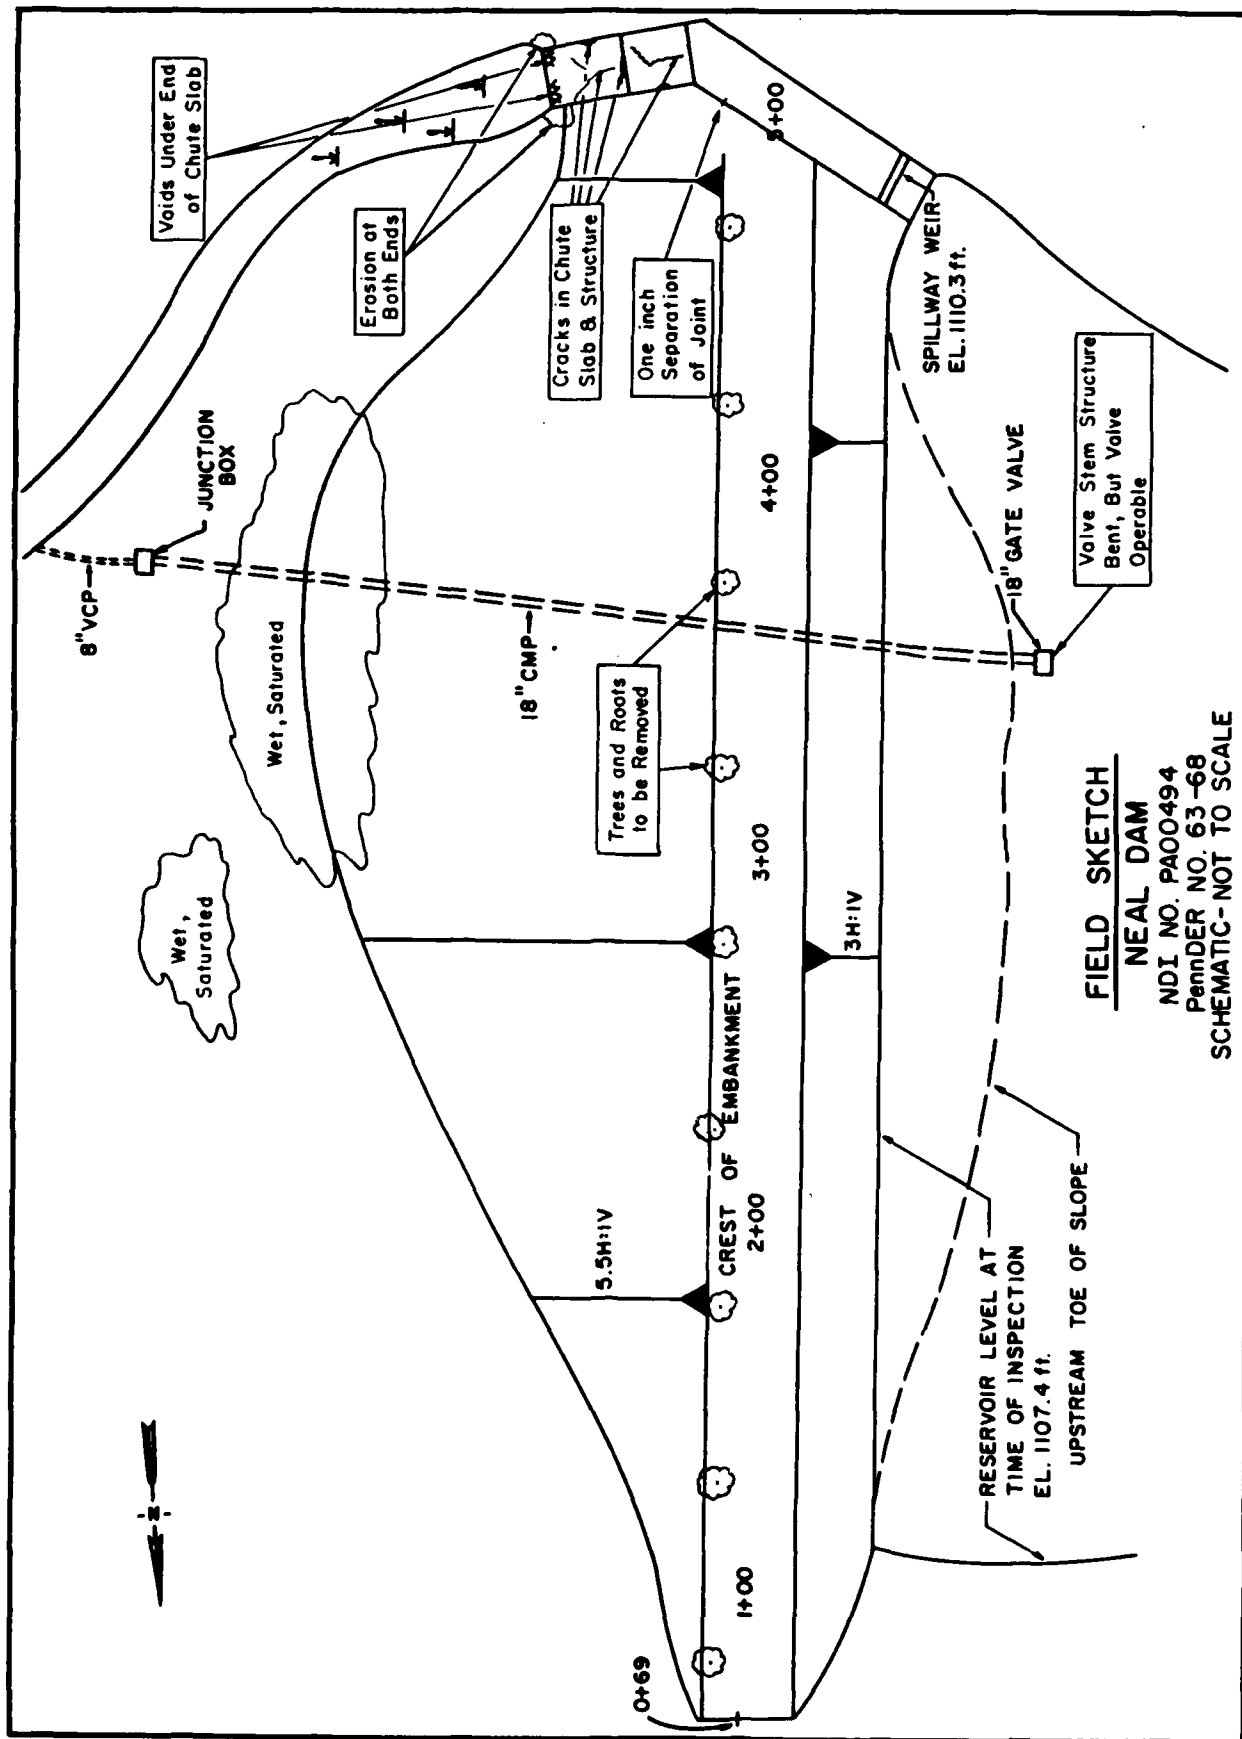
## FIELD SKETCH OF THE SPILLWAY

The concrete training walls have several large cracks in them. A couple of construction and expansion joints have partially separated. Some of the concrete in the spillway is honeycombed.

The concrete chute had several large cracks in the slabs. At the bottom of the concrete chute it appeared that the soil from behind both training walls was eroded. On the right side this erosion extended 3 to 4 feet beneath the chute slab and on the right side the void under the chute slab extended 8 or 9 feet back.
